WICKES, WIDNES COMMERCIAL

Central Group have completed a comprehensive roofing project at a Wickes store in Bowers Business Park, Widnes. This store supplies a huge range of trade-quality DIY and home improvement products. This project involved working on an active building site with other trades. The success of this project has led to further work with Wickes.

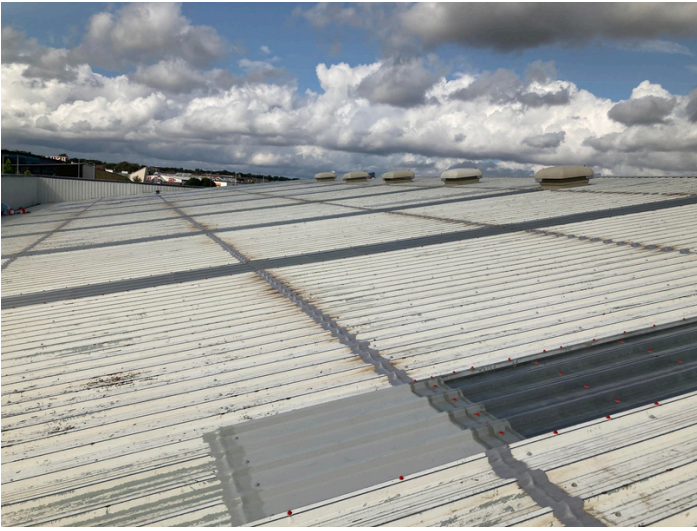
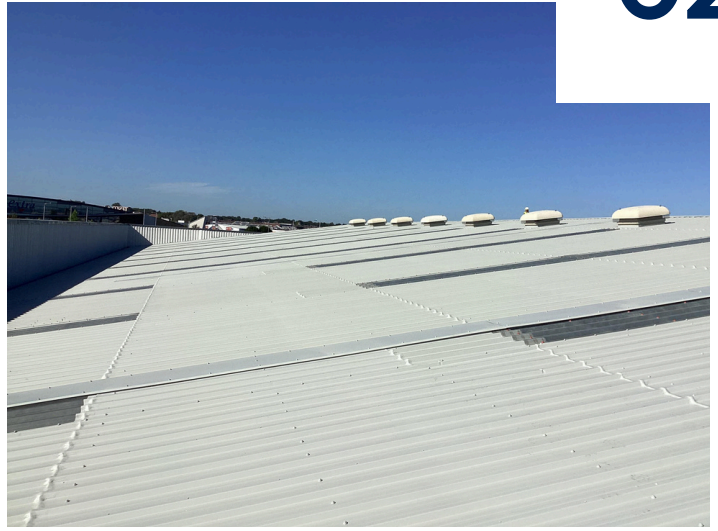
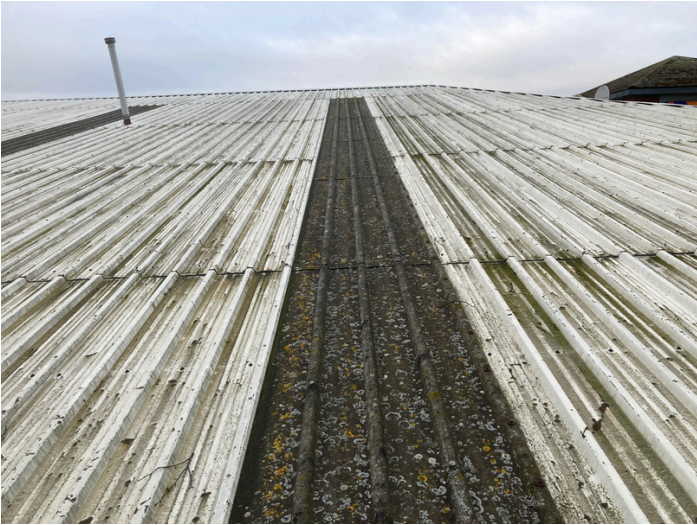
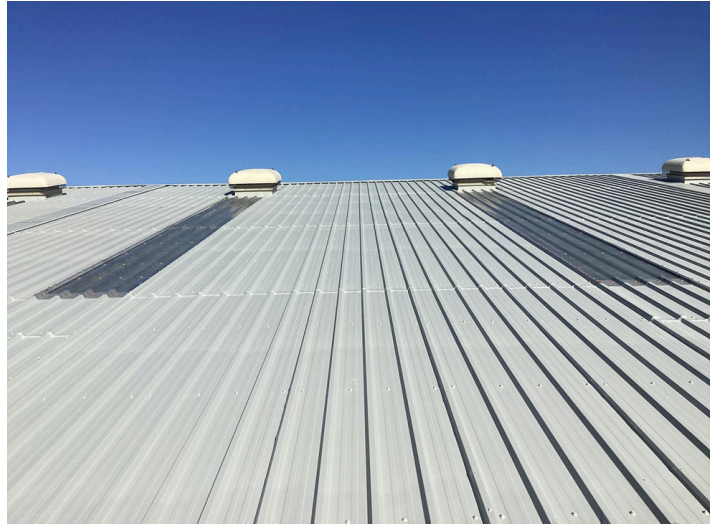
This Wickes store in Widnes faced challenges with its roof, because of its proximity to a coastal area, which causes more rapid deterioration of some metal types. The existing factory-coated plastisol roof sheets exhibited severe deterioration and delamination, as well as extensive cut-edge corrosion. Fixings had failed, and rooflights showed signs of deterioration. Gutters had suffered from extensive corrosion. A full refurbishment was crucial to restore the roof's integrity and longevity, as the existing system had surpassed its recommended lifespan.

HD Sharman roof re-coating works and guttering products were used, including the application of the Seamsil system to encapsulate the cut edge, with a new bolt encapsulation system for enhanced waterproofing and corrosion protection. Delcote GS guttering coating and Delcote Architectural coating were applied across the entire roof. Isolated roof sheets were replaced, with stainless steel fixings used to mitigate corrosion risks from the coastal environment. The entire roof was under-netted to ensure strict health and safety compliance.
