JORDAN HOUSE RESIDENTIAL

Jordan House, a high-rise housing tower block in Birmingham, was experiencing significant issues with its existing roof. The roof was damaged and nearing the end of its serviceable life, leading to water leaks into the building and causing considerable inconvenience for its residents.

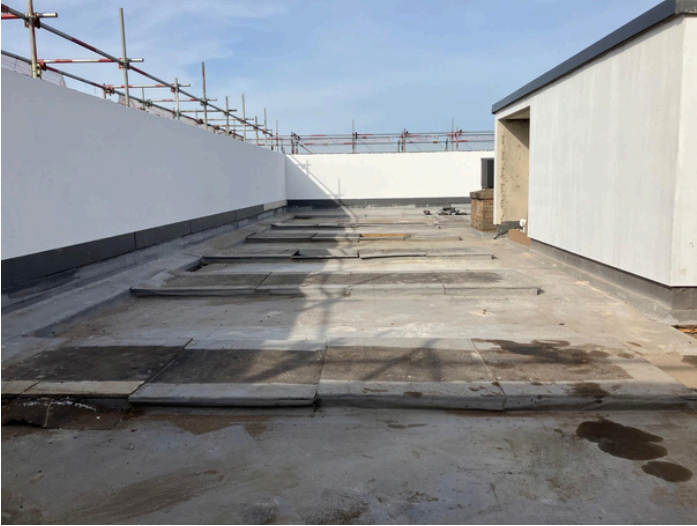
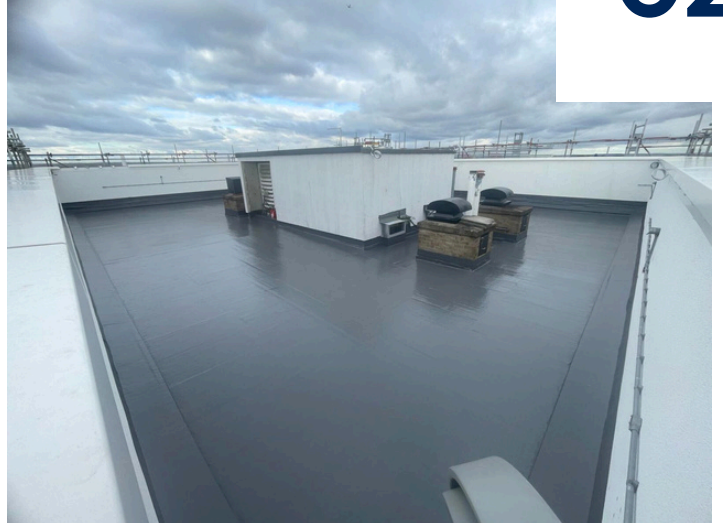
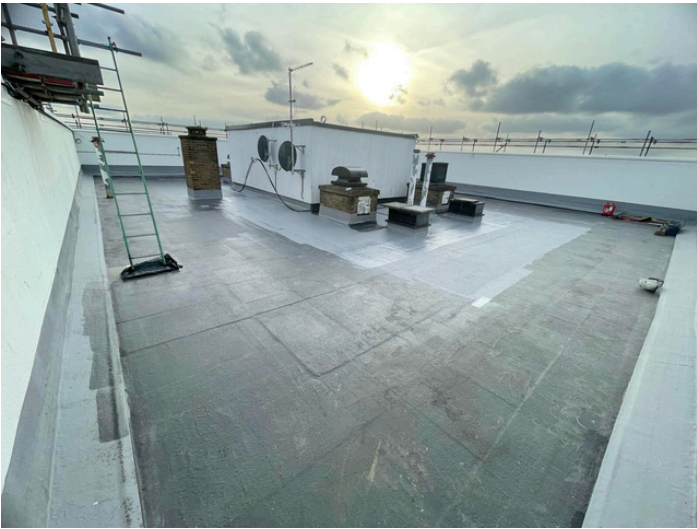
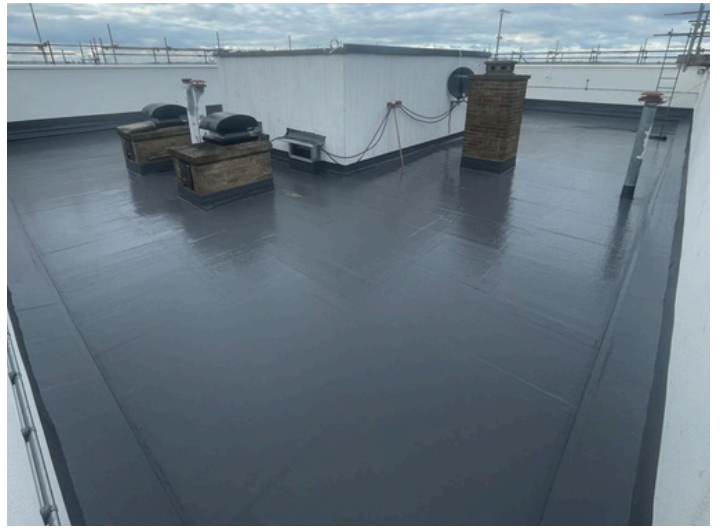
The project began with the sectional stripping back of the existing roof surfaces to the concrete deck. Following this, any imperfections or damage to the existing substrates, upstands, and other elements were repaired using appropriate materials to ensure a smooth and reliable foundation.

Next, the concrete deck was thoroughly primed to ensure proper adhesion of subsequent layers. A vapour barrier was then installed to prevent moisture ingress and protect the insulation layer. After this, cut-to-falls insulation was applied to ensure proper water drainage and enhance thermal performance.

Subsequently, a preparation layer and basecoat of Alumasc Caltech were applied, providing a robust base for the top coat. Finally, the top coat, utilizing a 3-layer system, was applied to ensure long-lasting protection and durability for the roof.
